Record of repair of bell-frame and bell retuning

Redgrave St Mary
November 2017 to February
2019

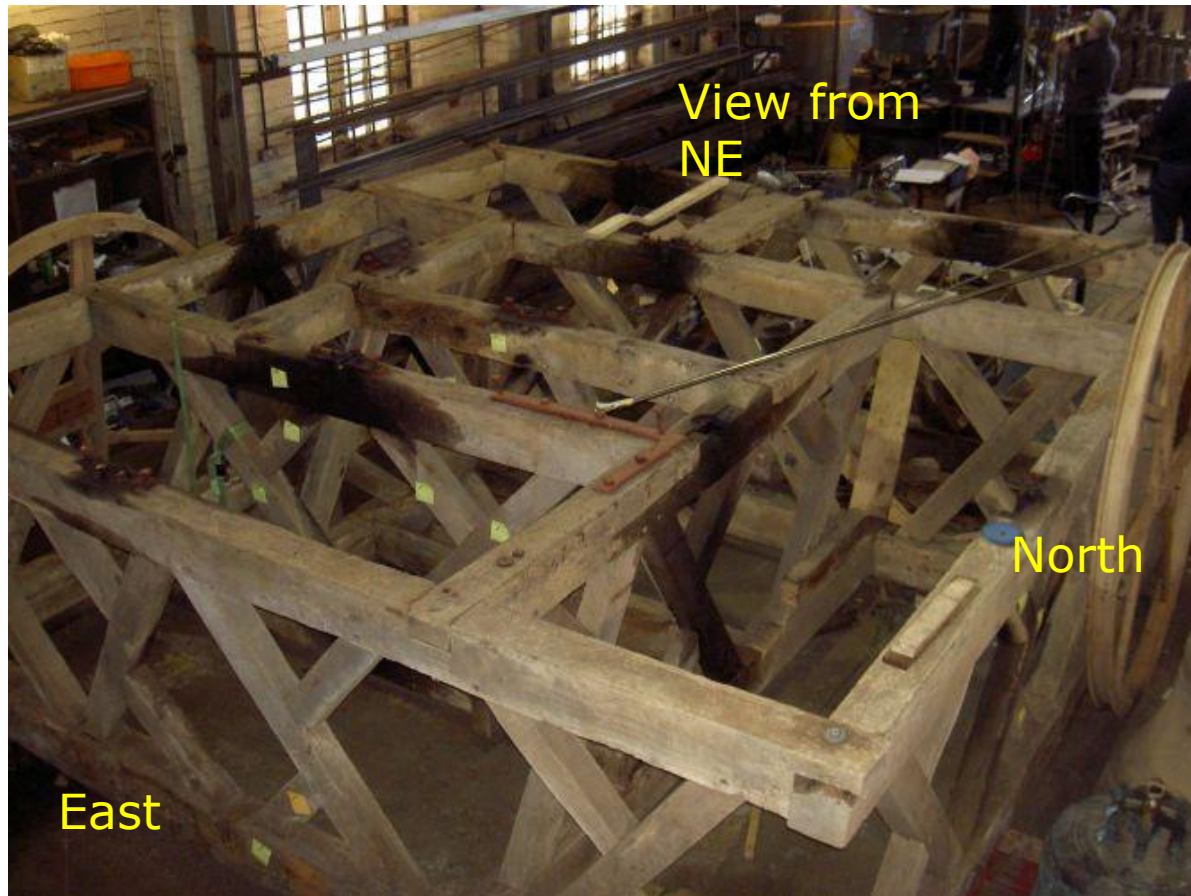
Bell frame was reassembled in factory
to assess what repairs were needed

It took 14 months to repair

- One third of all timber replaced
- Most of the 174 joints reassembled
- 56 steel brackets all truss junctions
- 4 corner posts added with massive brackets
- Steel base frame made for setting into walls
- All bolted to the steel base frame
- Bells re-tuned on vertical lathe
- Made new headstocks, bearings, stays, sliders, wheels, pulley blocks, clappers

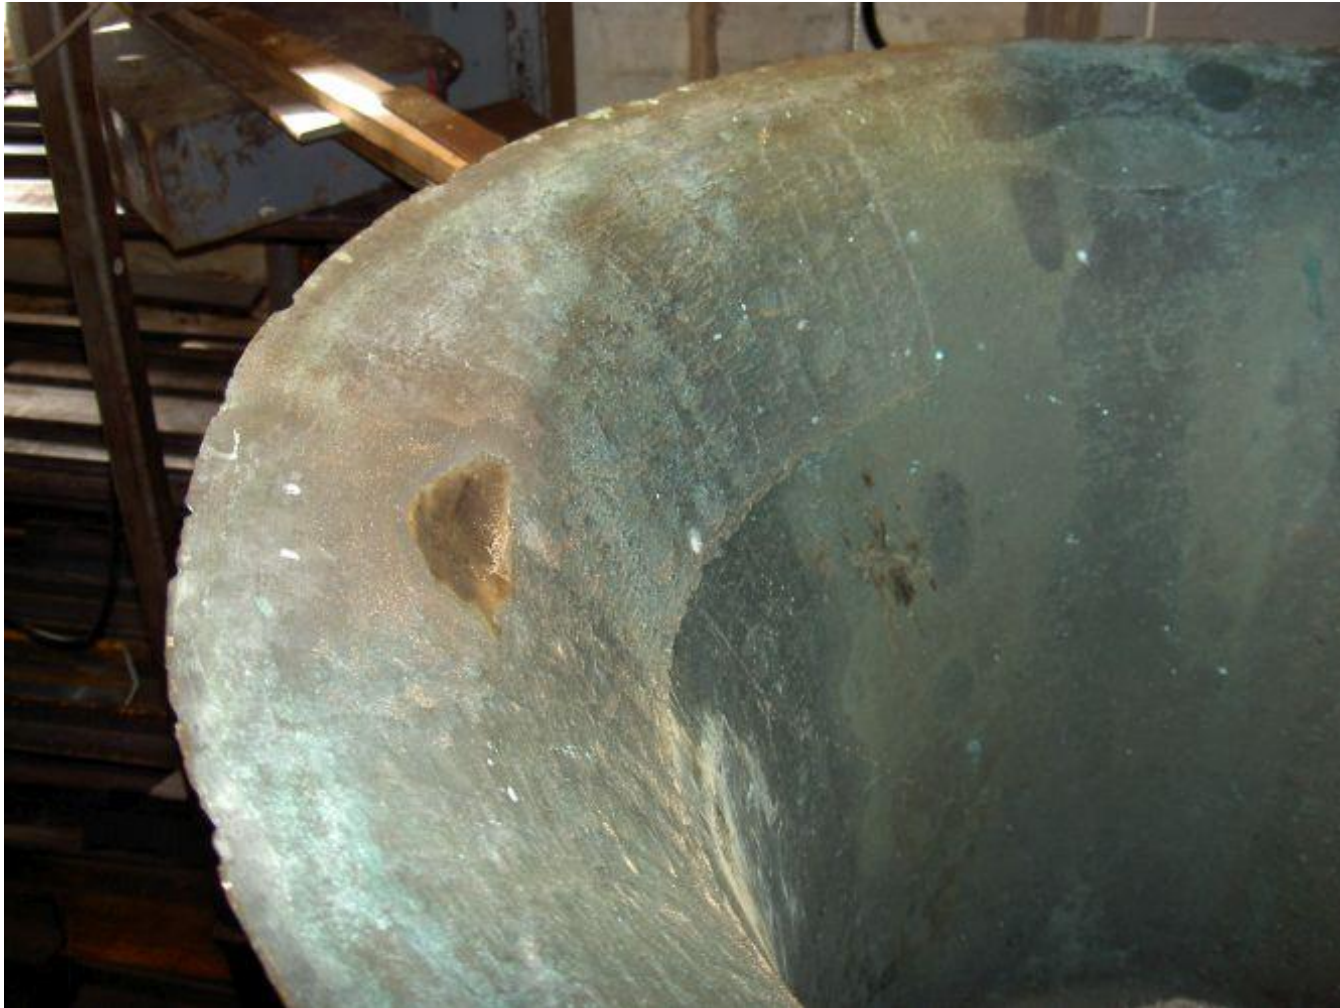
Before tuning showing strike
on No 2

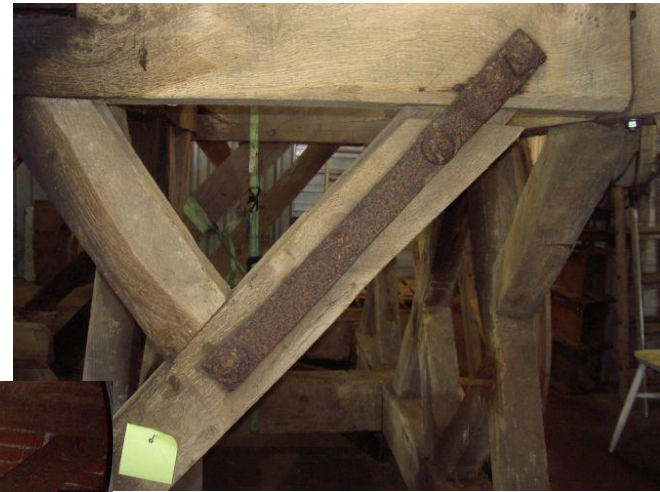
Flagpole fitting
bolt
South end of E2
(Evidence of
pole hole in roof
but
predates any
photos)

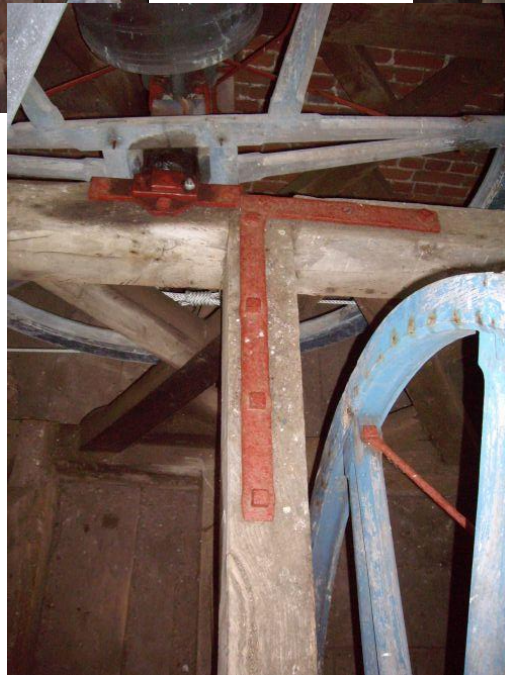
Repair of 1886 bell
No 3
South end W2
Headstock broke
and bell
fell off
Repair or
strengthening L
shaped bracket date
unknown at join E2

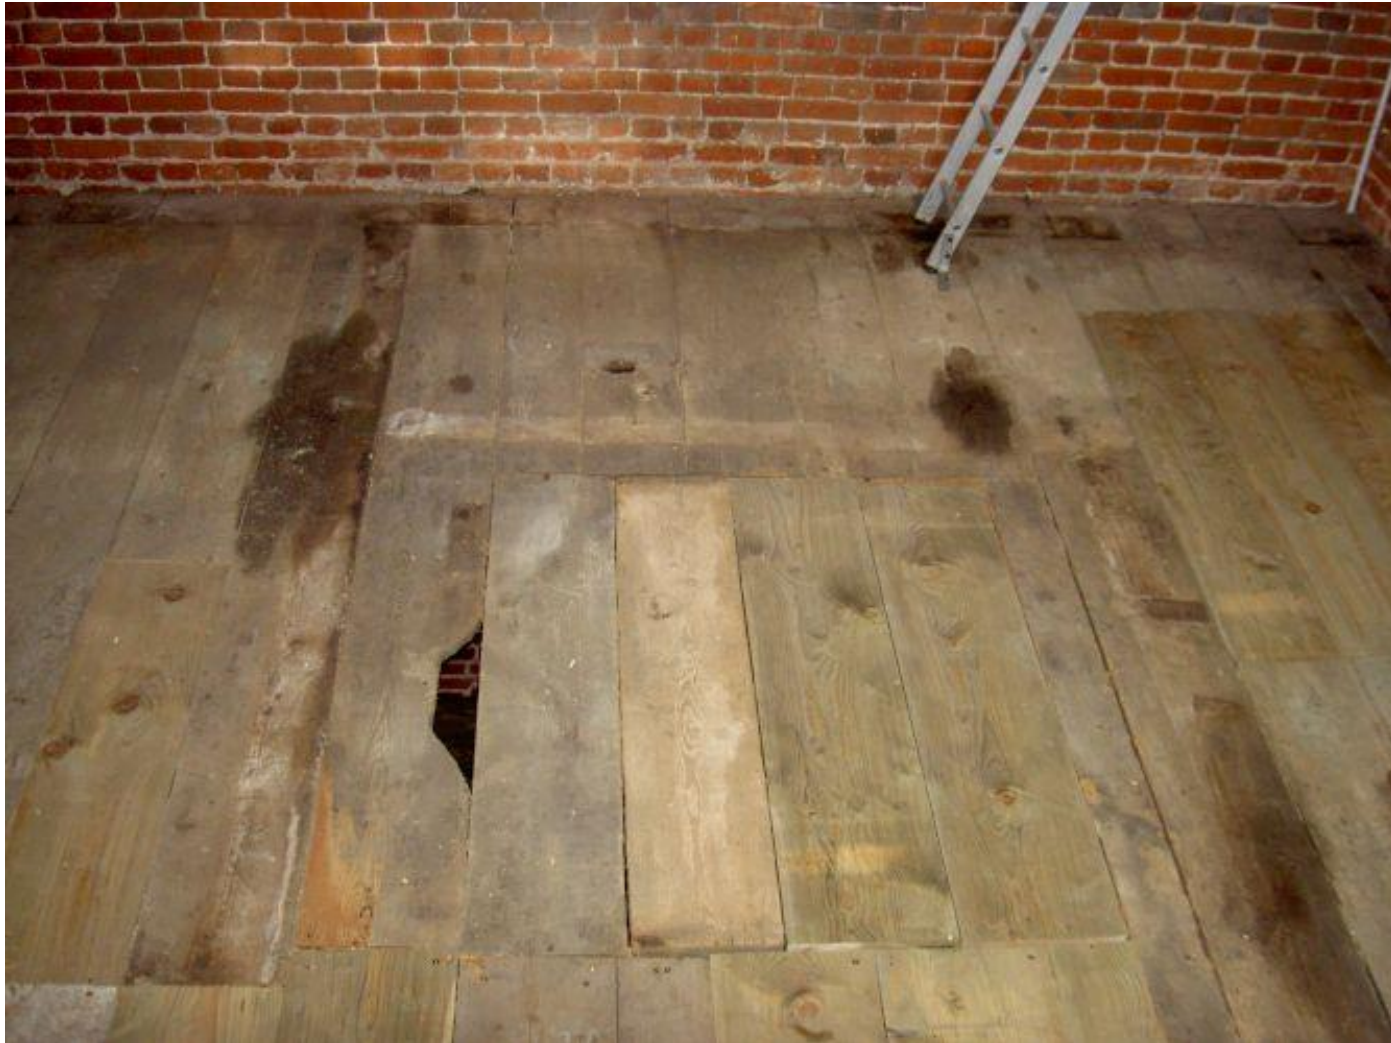
Bell chamber floor repaired

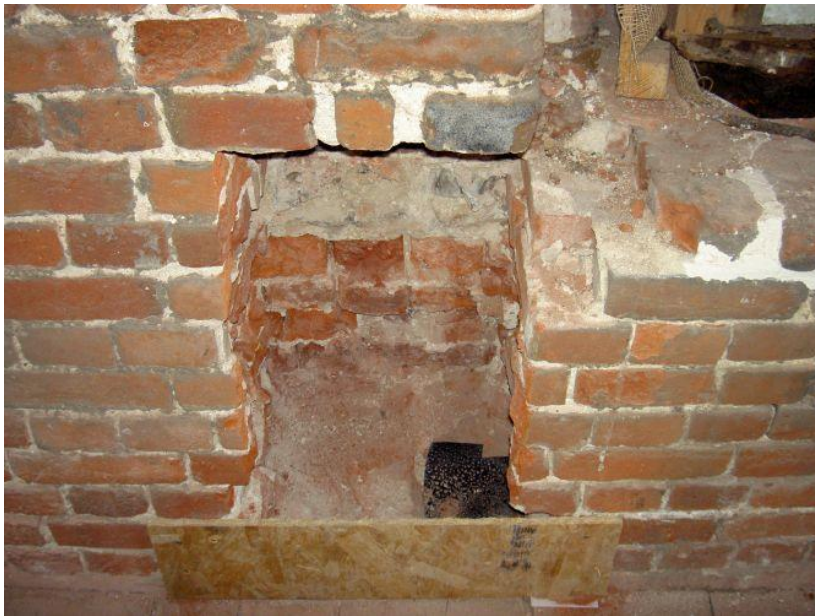
15 holes for beams & padstones

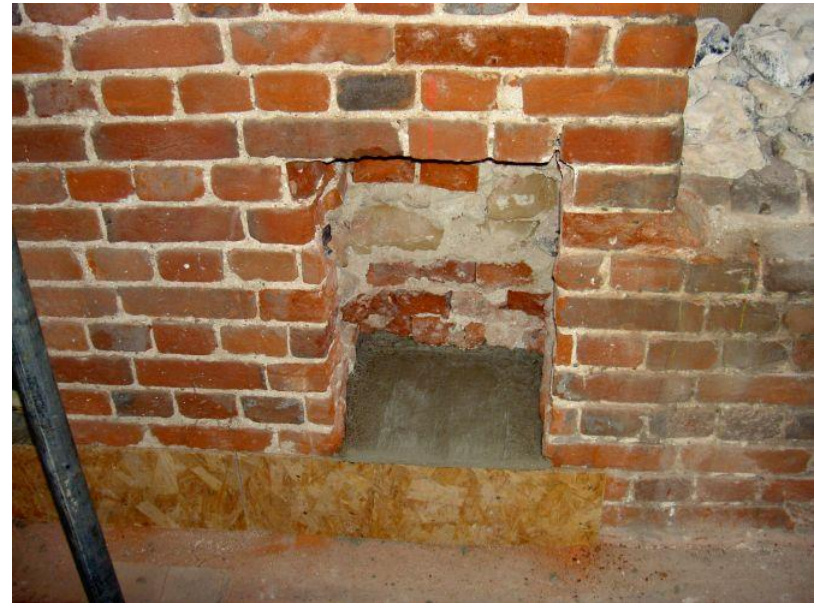
Hole cut and shuttered

Padstone poured in 40N bag mix

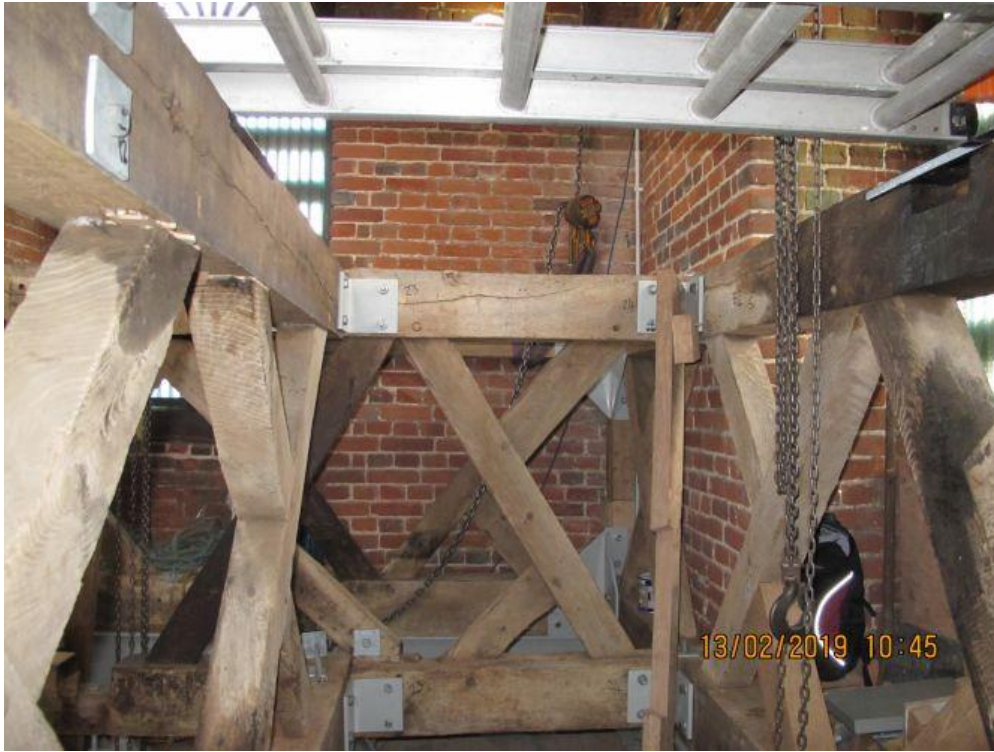
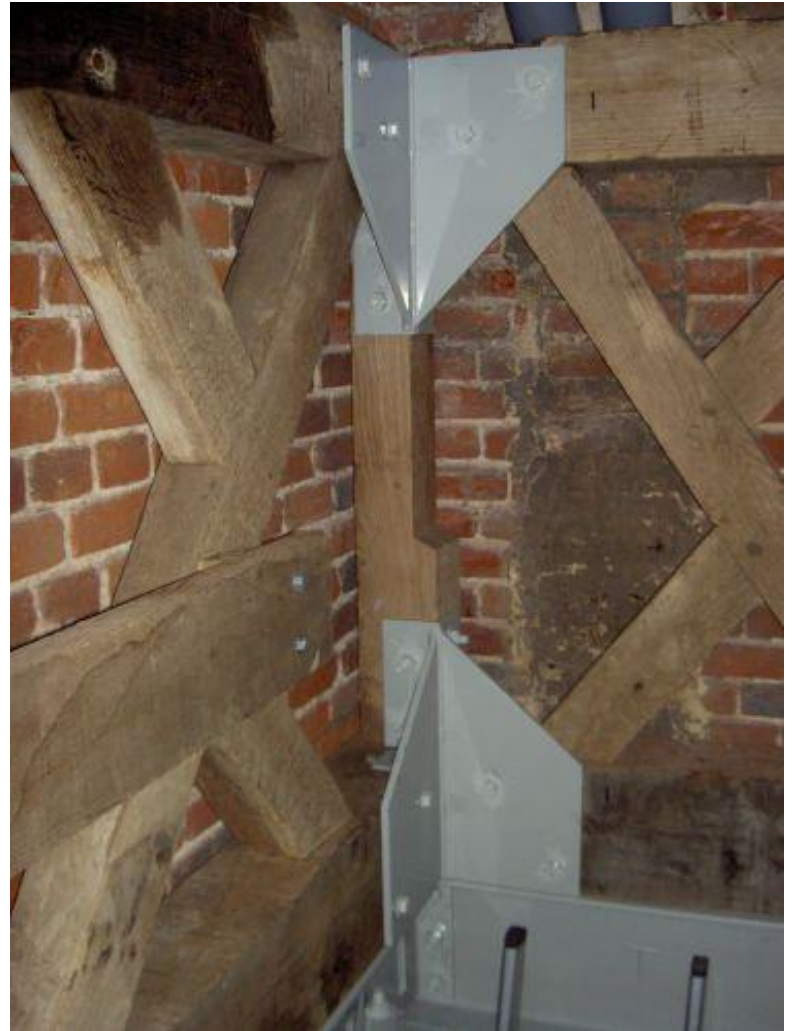
Historical note: The bell frame was a classical Elphick type W which did not have corner posts.

New corner posts & steel brackets
